# COMMERCIAL ROOF COATING

**JOB :** Investments Limited Roof Restoration

**ADDRESS :** 420 Royal Palm Way, Palm Beach, FL 33480

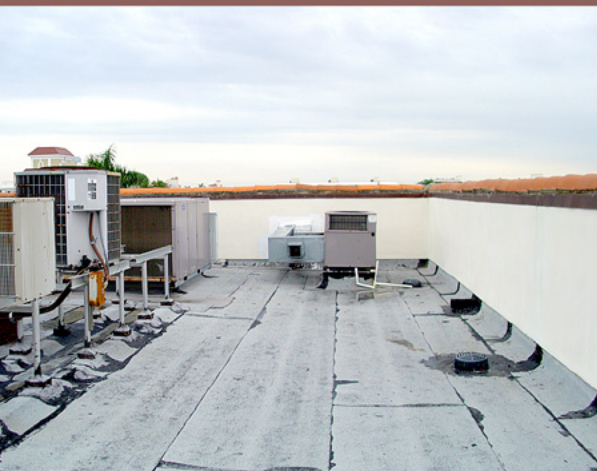
BEFORE

**ISSUE :** Due to severe rainfall and storm damage over the years, a common environment for commercial roofs and properties in Palm Beach, FL, excessive debris and mold had accumulated on this flat rooftop. As a result, various “blisters” had formed.

Blistering rooftops can create several, expensive problems over the life of a roof. Caused by a delamination of the original exterior barrier due to water penetration, blisters create weak points where water can seep further into the roofing membrane. The result is compromised life expectancy and diminished integrity of the roof because of rotting materials.

1. Clean and remove all debris and mold.
2. Cut out and repair any and all blisters per manufacturer’s request.
3. Apply Gaco Western E-5320 primer to all exposed asphalt areas.
4. Furnish and Install Gaco Western S-2000 silicone coating at a rate of 1.85 gallons per 100 square feet, which holds a full manufacturer, 15 year water tight warranty, non pro-rated.

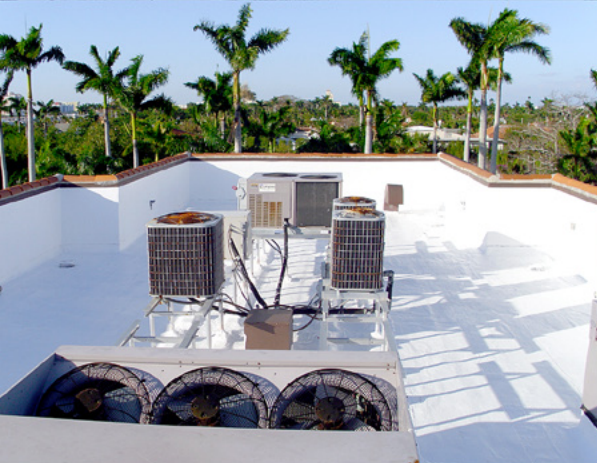
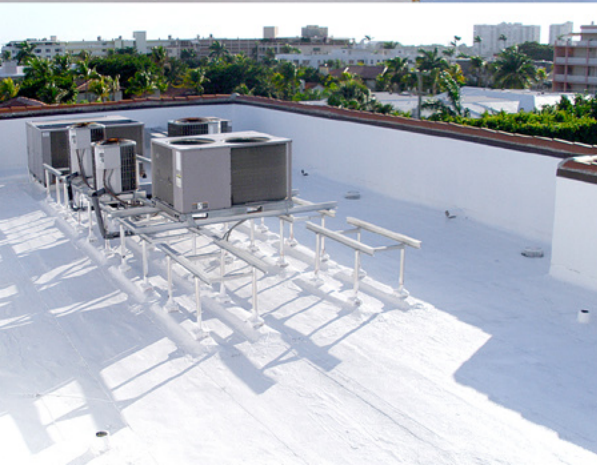
AFTER

Cleaning and coating the existing roof saved the property owner significant cost over a complete reroof. The new coating will provide rain and weather resistance for years and is backed by a full warranty.
